## OMC Project Description – Railway line-side structure monitoring

*The rail infrastructure requires regular inspection to ensure that it is within acceptable boundaries. For example track camber, position of overhead lines, and gantry support locations may all need to be measured.*

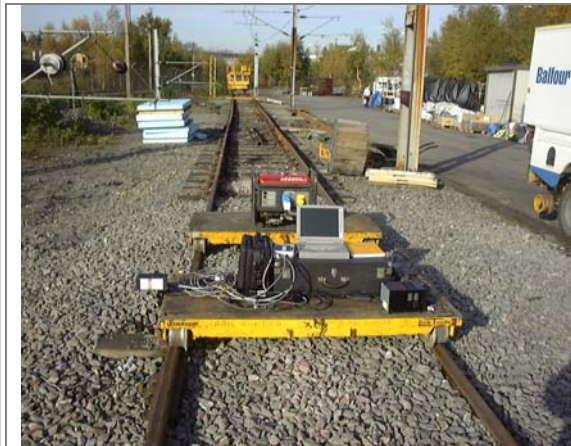
The tested instruments were taken on site where practical tests were conducted to assess performance in realistic conditions where temperature, sunlight or other factors such as vibration might affect the measurement process.

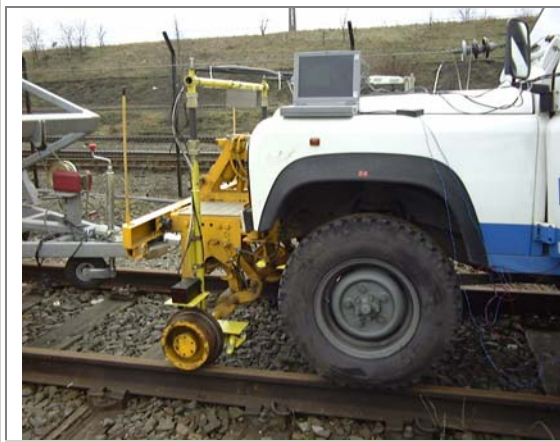
Further field trials were conducted using a modified Land Rover vehicle where all of the sensors were integrated together to measure camber, rail offset and distance to line side structures.

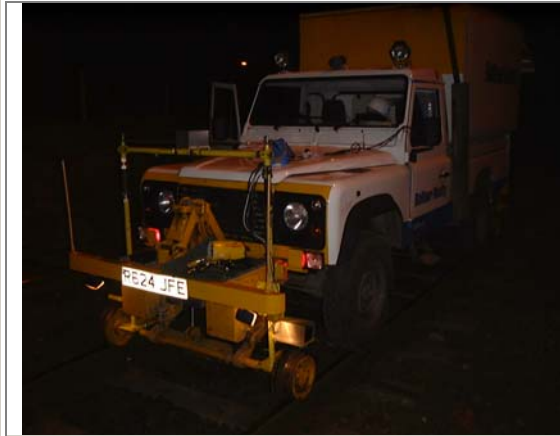
A night possession of a railway line was used to conduct a final test the system before commercial development was handed over to another company.

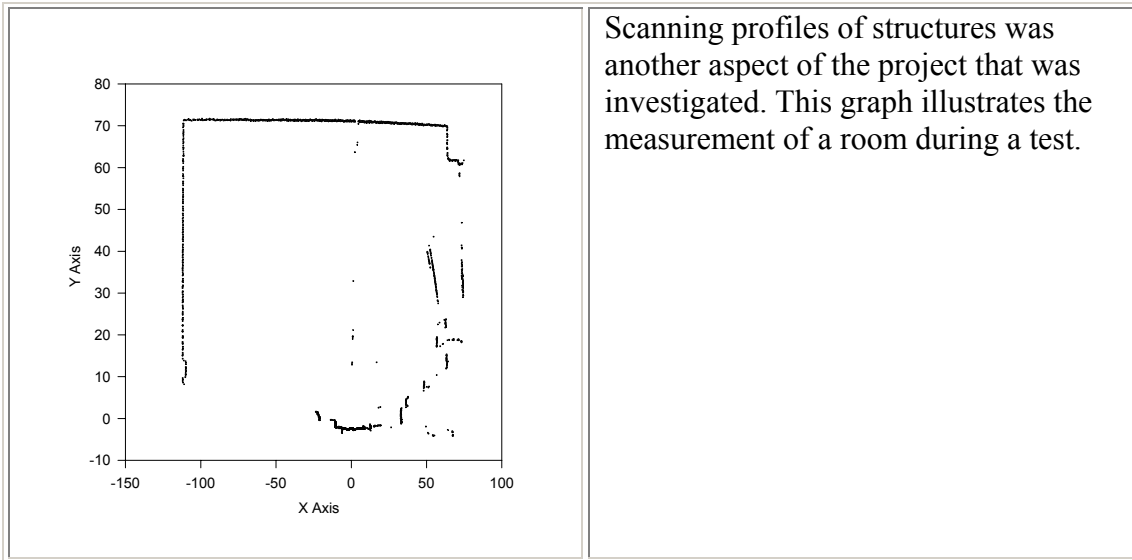
Scanning profiles of structures was another aspect of the project that was investigated. This graph illustrates the measurement of a room during a test.
